2016 Annual Inspection Report

**Lake Borgne Shoreline Protection
Project**

State Project Number PO-30
Priority Project List 10

July 20, 2016
St. Bernard Parish

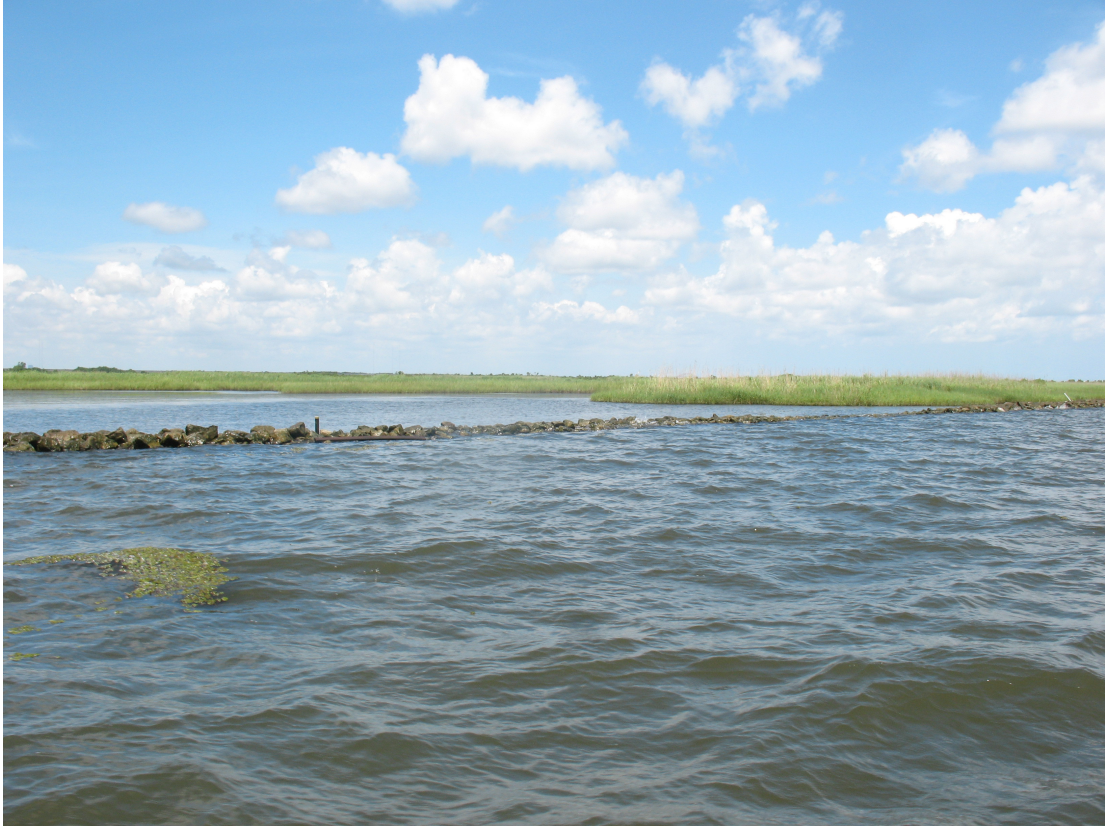
Reach 1 – Shortly after construction and the passage of Hurricanes Ike and Gustav the rock breakwater settled below the mudline for much of its length. The 2013 maintenance project placed a rock lift in reach 1 and installed a composite sheetpile wall in the areas where rock had settled below the mudline. Most of the rock was in good condition with only small localized area of minor settling (N29d 57m 17.70s). Most of the composite sheetpile wall was in good condition except for 2 areas that were damaged and no longer functioning as a breakwater. One area near, Bayou Dupre, was approximately 330' long (N29d 56m 54.85s, W089d 50m 31.18), and two smaller areas about one quarter of a mile northward (N29d 57m 35.35s, W089d 50m 50.53s).

Reach 1 – Rock Breakwater Settlement

- A maintenance project is scheduled for this year to address the gaps in Reaches 1 and 3 Weak along with the settlement anticipated during design. The missing warning sign at Reach 2 Double Sheet-pile Wall Breakwater will also be replaced.

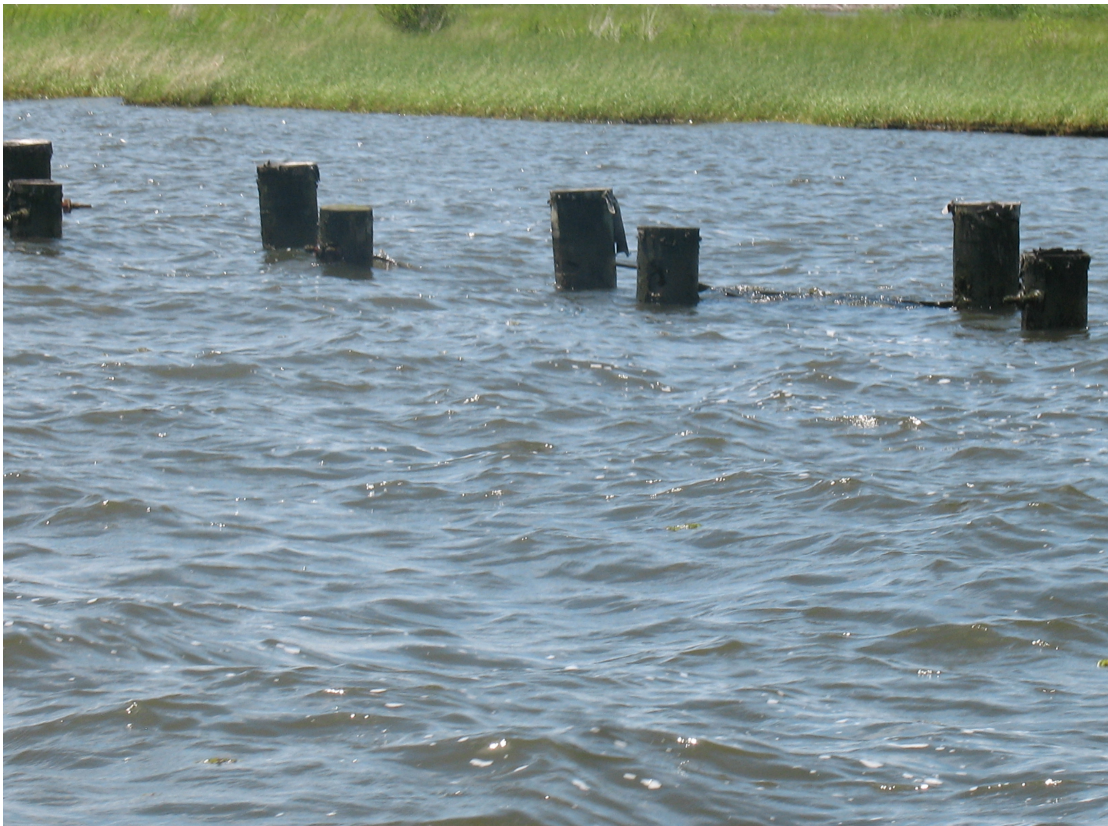
In the area near, Bayou Dupre, soundings were taken with a bamboo pile for a length beyond the damaged area. These soundings revealed that the scour protection in the damaged area had settled to a depth of about 10 to 12 feet and was about 7 feet deep in the undamaged areas beyond. In the damaged area, this is significantly deeper than the design depth for the wall.

A follow-up inspection was conducted on January 5, 2017 to take additional soundings in all of the damaged areas and to observe if the extent of the damage was increasing. The water level was approximately +1.0' MSL (by the tide gage at the Bayou Bienvenue lift bridge/flood gate and by observation relative to the project structures). The soundings were similar in the area near Bayou Dupre and the two smaller areas. However the two smaller areas appeared to have grown in length, possibly due to the greater visibility allowed by a lower water level than at the previous inspection.

Reach 1- Damaged Sheetpile Wall

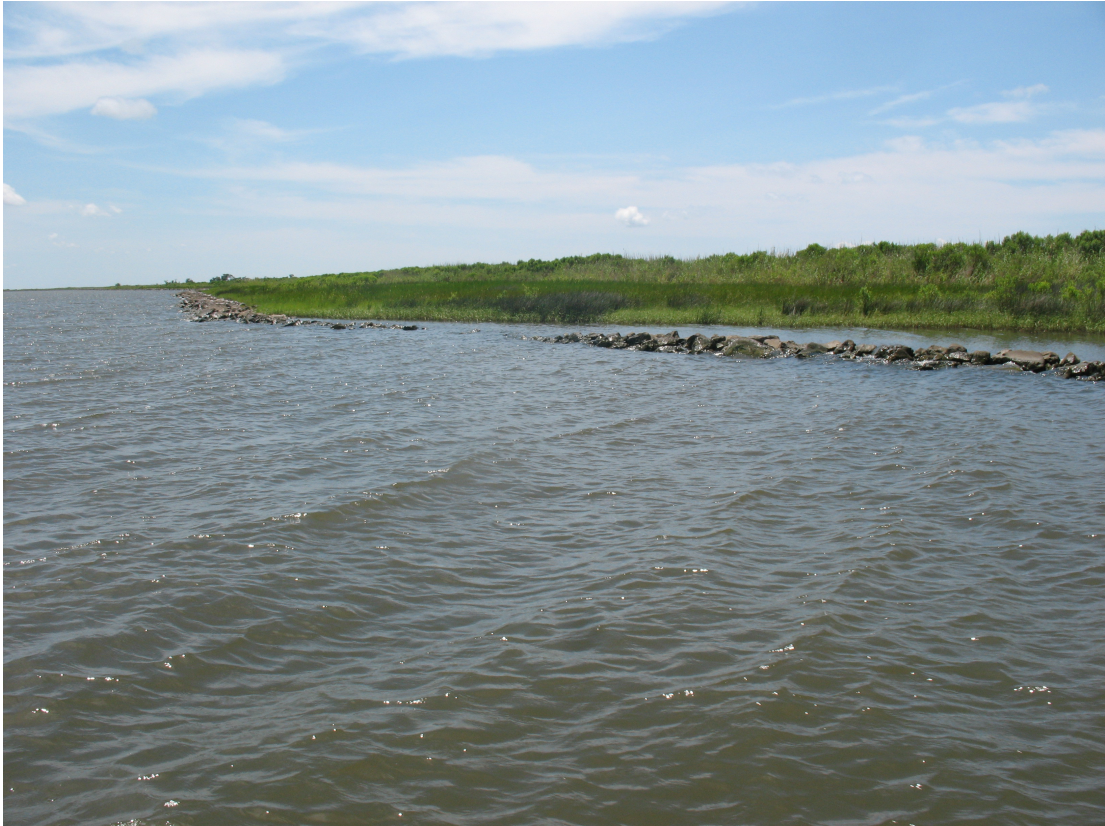
Reaches 2, & 3(strong) - The breakwater reaches appear to be in good condition, except for limited areas that have settled and should be monitored for possible future action.

Reach 2 Approximately 100' near N29d 56m 30.66sec.

Reach 2 – Rock Breakwater Settlement

- Continue to monitor the condition of the breakwaters.

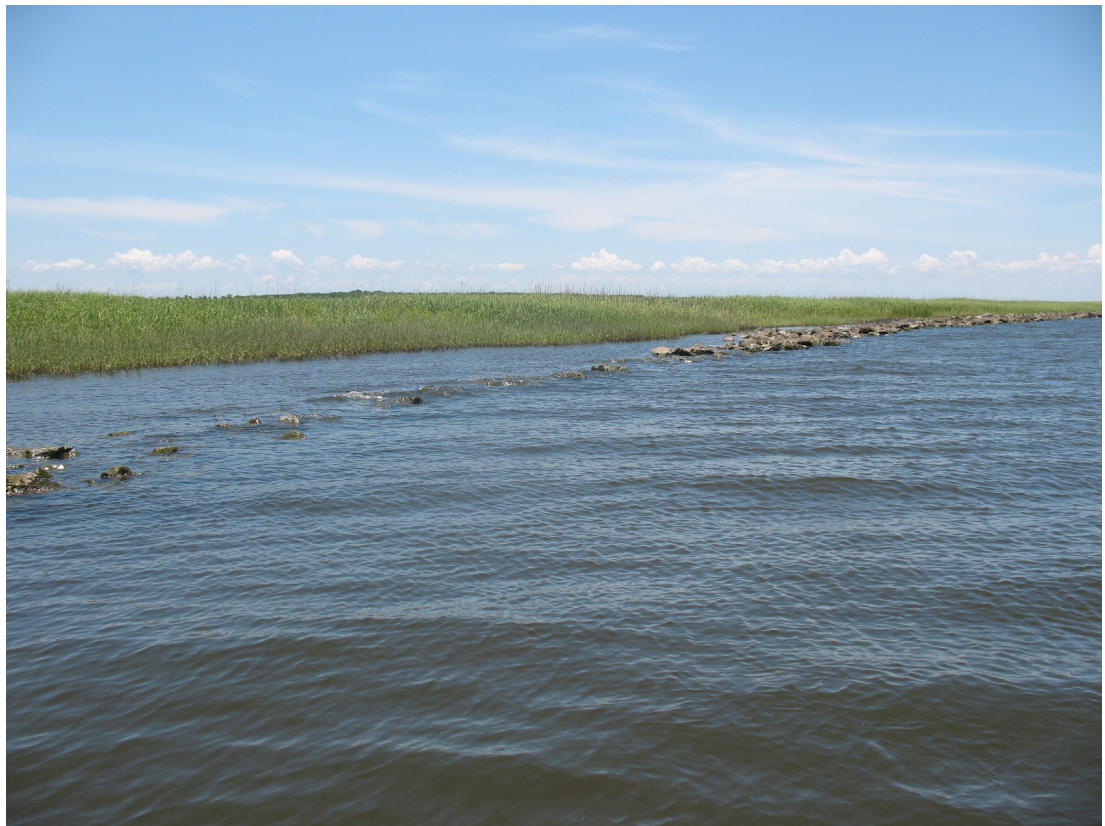
Reach 3 (strong). Approximately 100' at mouth of Fort Bayou

Reach 3 Strong – Rock Breakwater Settlement

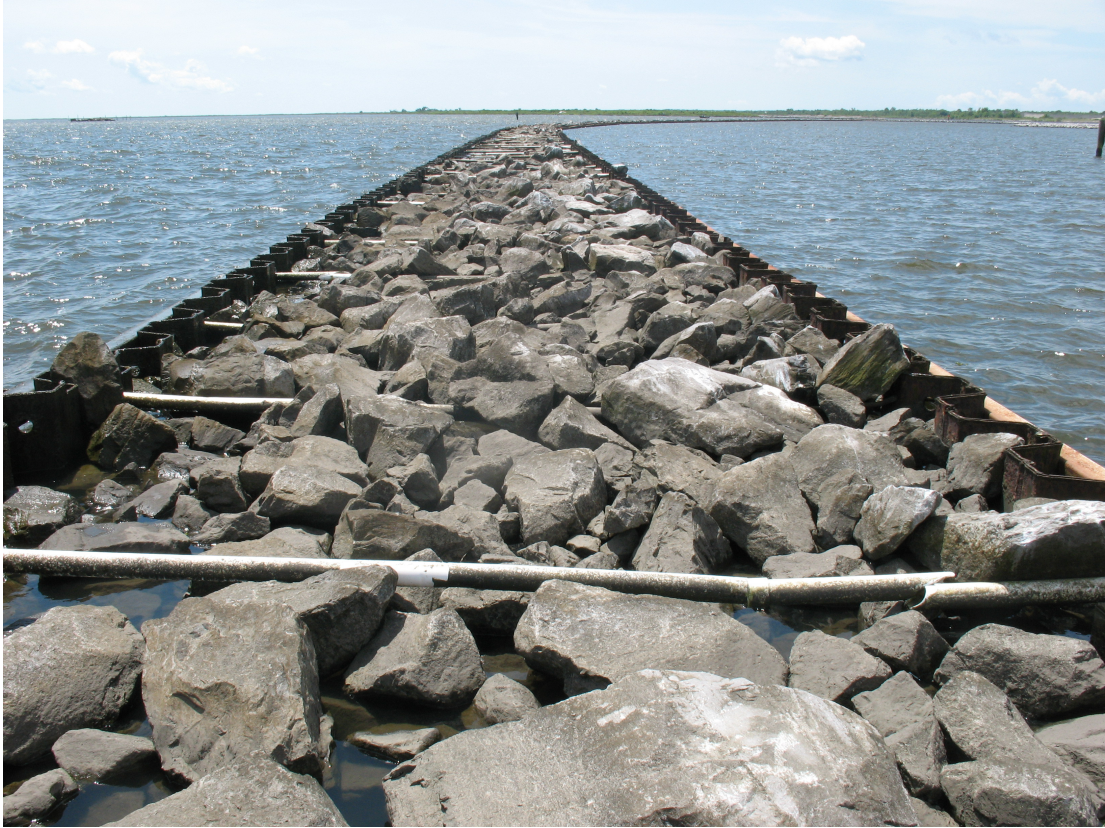
The Double Sheet-pile Wall Breakwater appear to be in good condition. Although there are some sections of settlement and some corrosion of the steel in the splash zone it is performing its function.

Double Sheetpile Wall Breakwater
